Atlantic Salmon Recovery & Conservation Plan for the South River Watershed

The Antigonish Rivers Association

May 31st, 2021

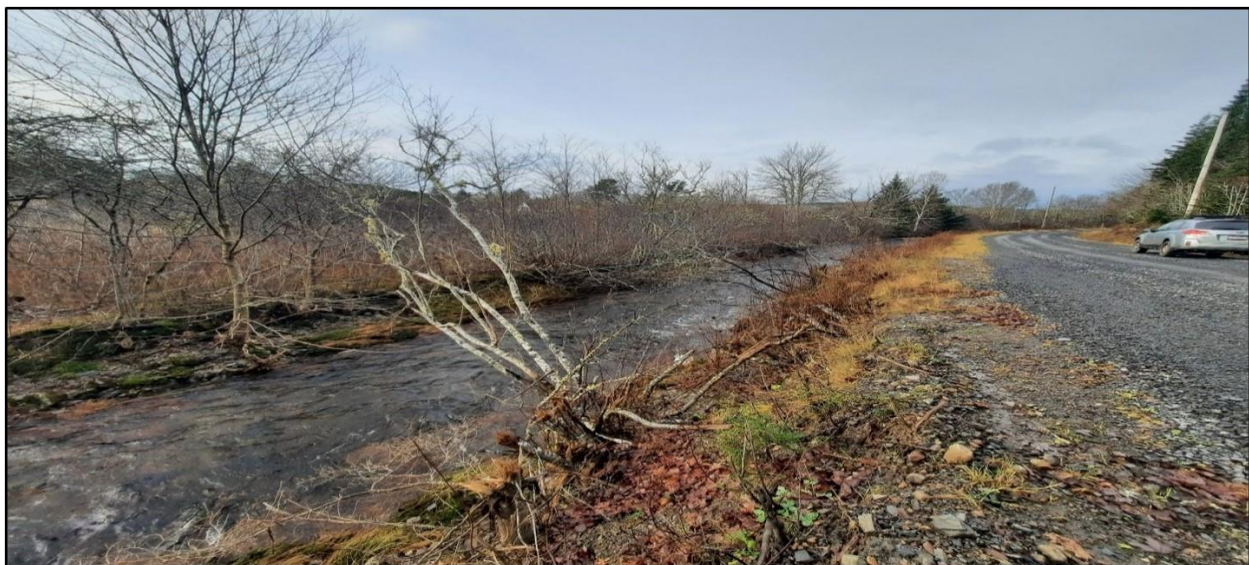
Figure 7: Argyle Road runs in close proximity to the South River with no buffer zone between

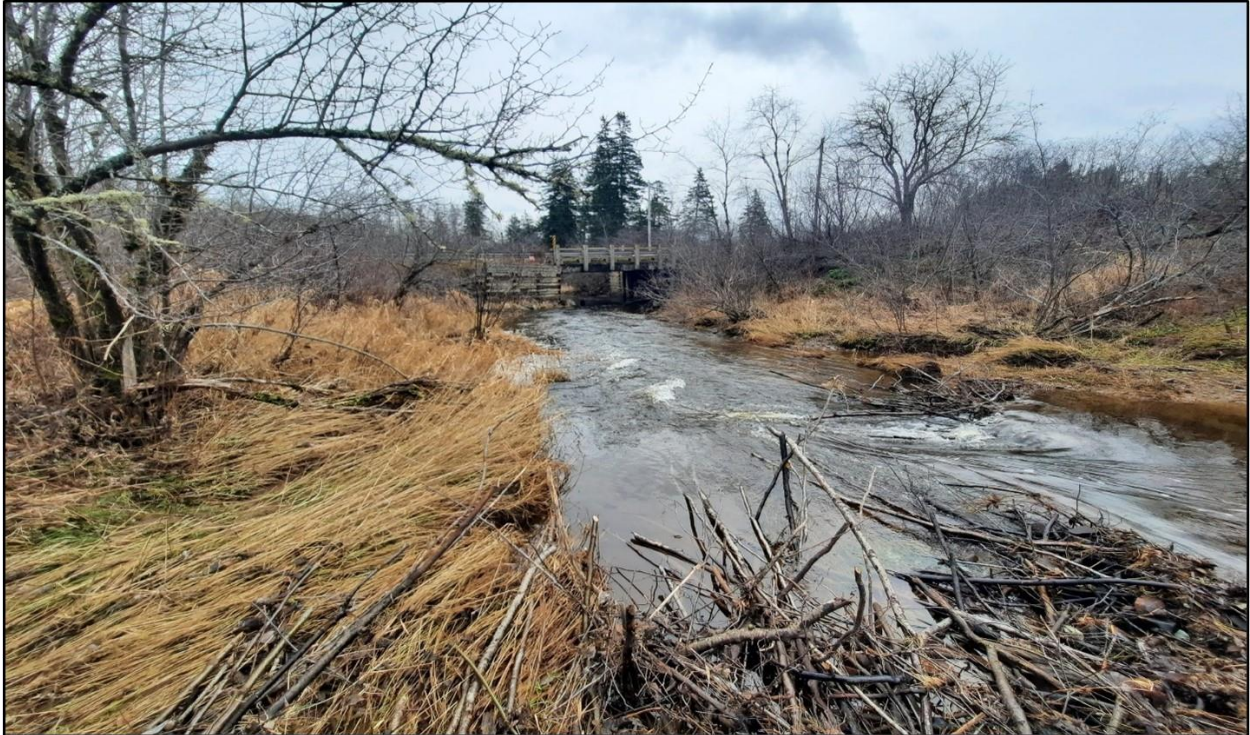
Figure 28: Downstream view of the Dunmore Road crossing, beaver activity observed

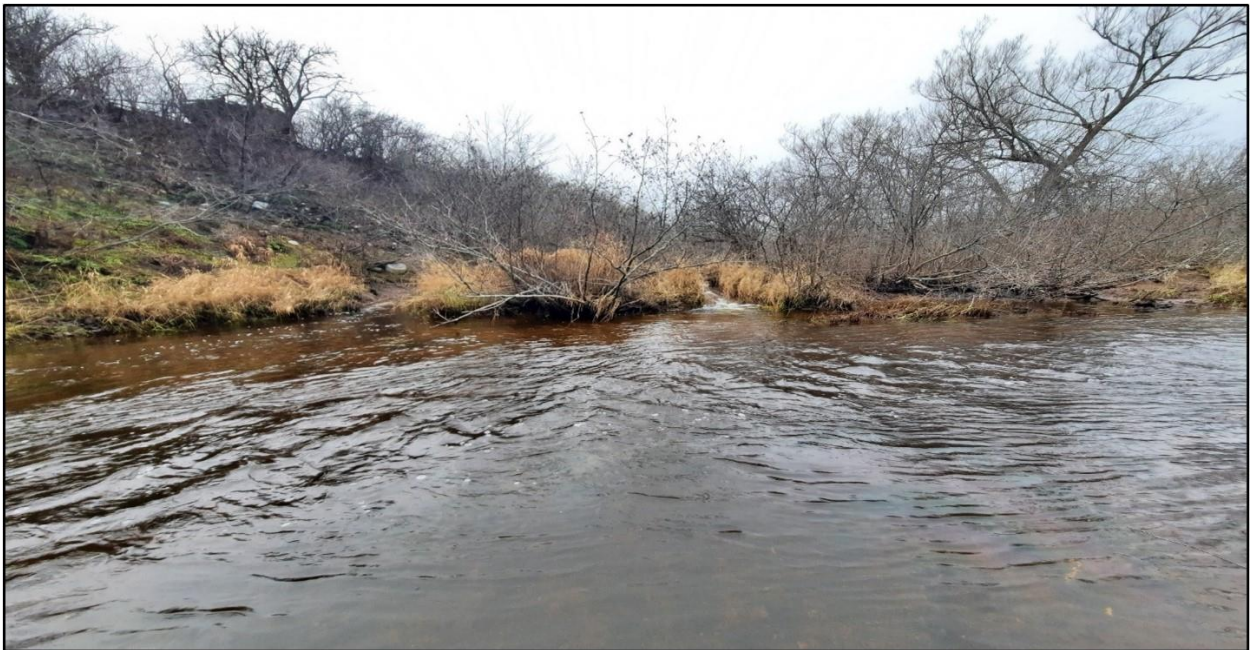
Figure 29: Upstream view from Dunmore Road crossing where beaver activity has caused back flow and fine sediment deposit in the substrate

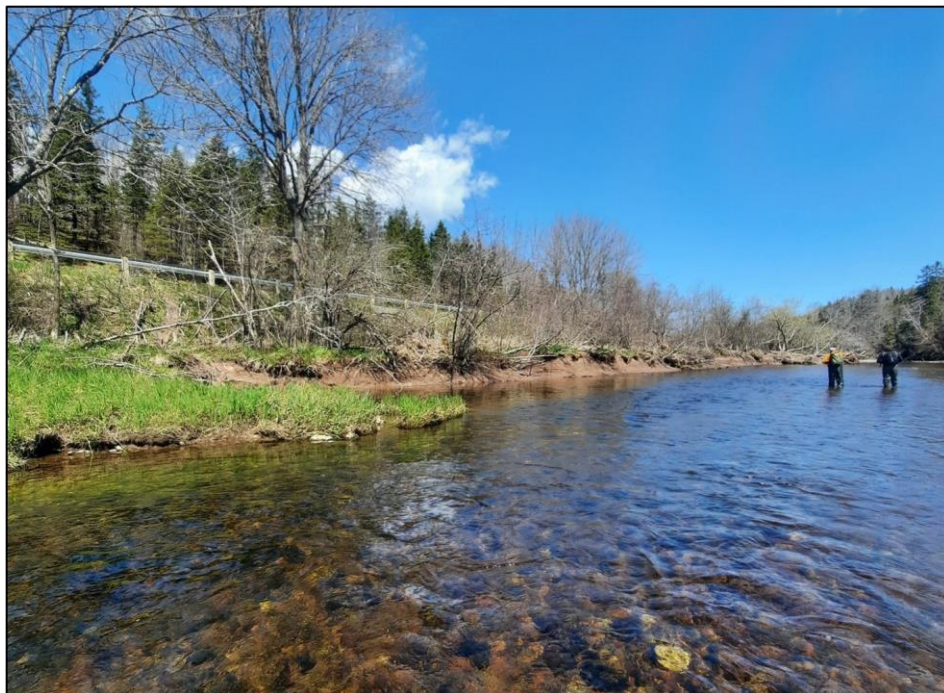
Figure 39: The Dunmore Road runs in close proximity to the South River

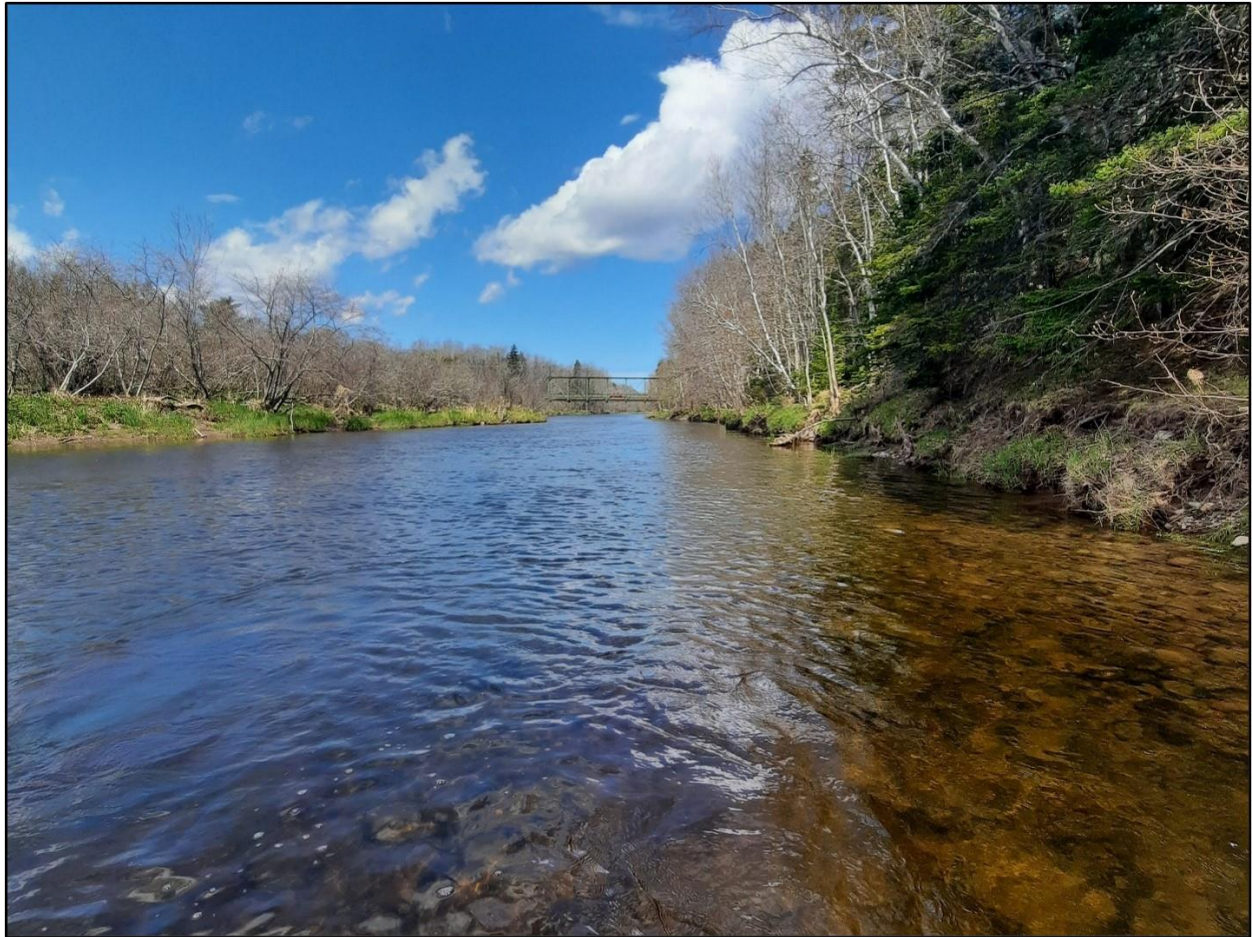
Figure 50: Looking downstream towards the Blacksmith Valley Road bridge

As seen in the above photo, the river was historically channelized in order to achieve the perpendicular flow to the bridge. This has caused over-widening of the channel resulting in shallow water with no defined thalweg. The water temperatures during the summer months reach above 20°C, which is the point when Atlantic Salmon begin to really feel the stress and often times will die. Another reason for the extreme temperatures in the summer is lack of riparian vegetation to provide shade. During the winter months, the shallowness of the entire width of the channel causes freezing down to the substrate in some sections which can kill off the fertilized eggs in the salmon redds that are buried in the substrate. The floodplains provide many functions in a river system, one of them being an overflow for ice sheets in the winter, but due to the loss of connection between channel and floodplain, the ice sheets stay in the channel and cause jams along the river that scour the substrate down to bedrock in

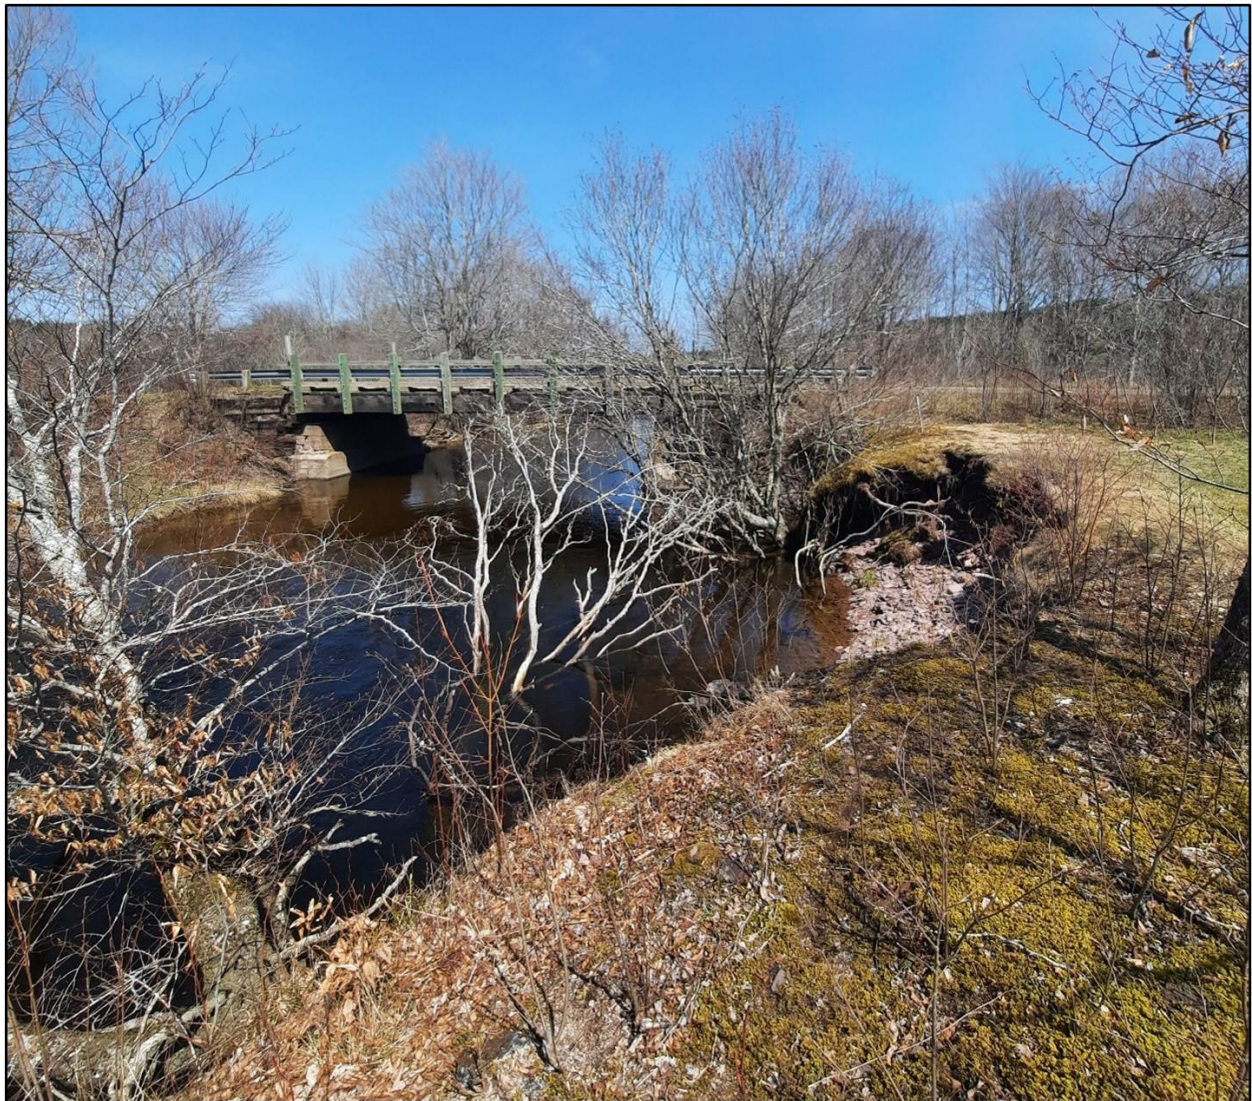
The bridge on this section of the South River is too narrow for the peak flows of the South River and as a result there is severe bank erosion (seen to the right). What happens here is the water gets backed up due to the narrowness of the bridge and it creates a whirlpool that will eat away at the upstream bank – especially if there is not enough large vegetation to hold the soil in place. This site, similar to the previous photo, was channelized when this road crossing was built and has caused similar issues of overwidening, and shallow, warm water. The winter ice jams can be quite severe in this upstream section because they cannot flow freely under the bridge, and they are not able to be deposited into the floodplain so they get backed up and cause more erosion along both sides of the river upstream.

Figure 51: Looking downstream at the Cumming Mills Crossing Road bridge

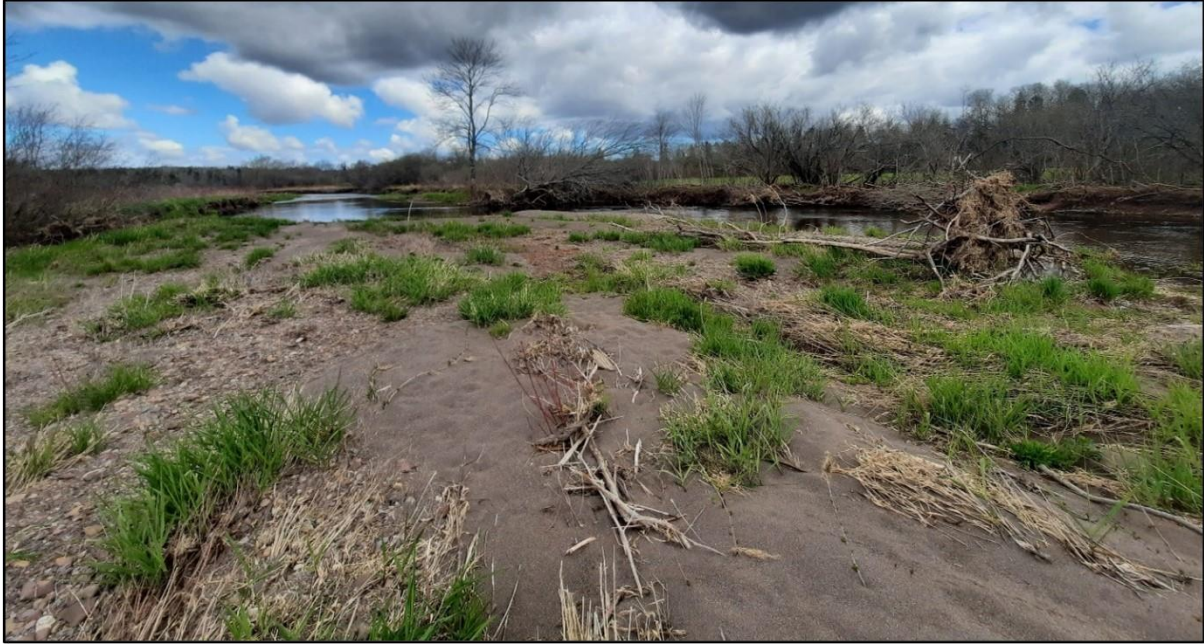
Figure 82: Gravel bars forming along the South River

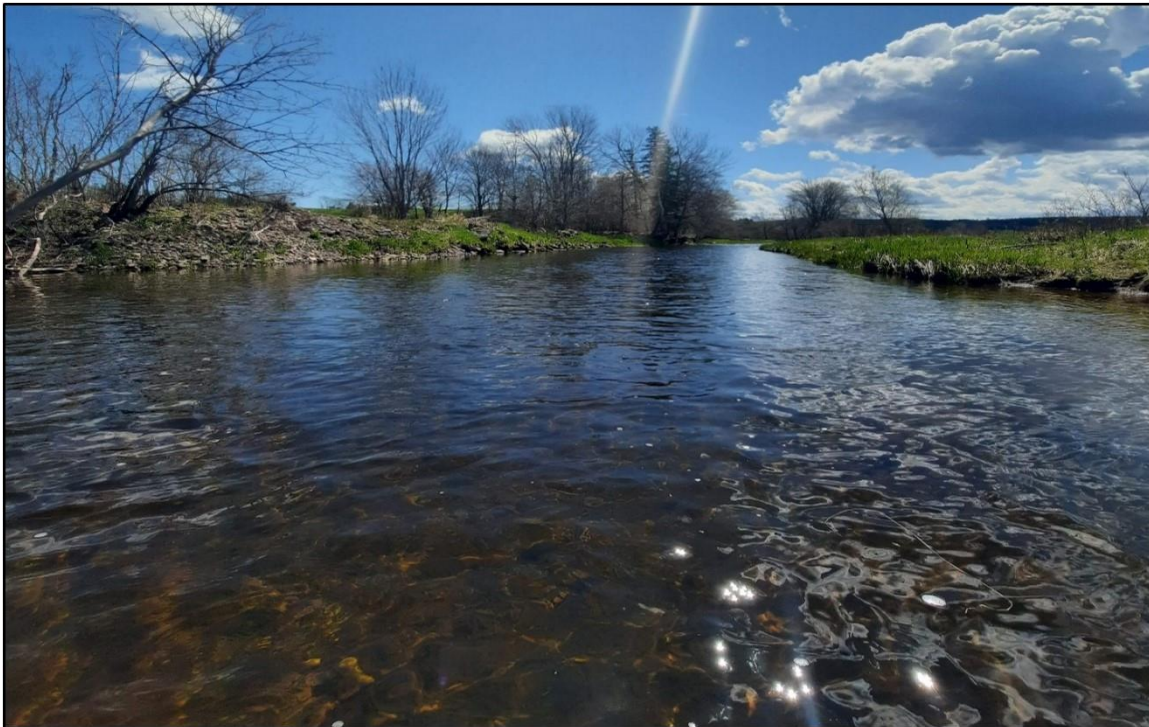
Figure 83: Long straight stretches along the South River with little riparian zone presence

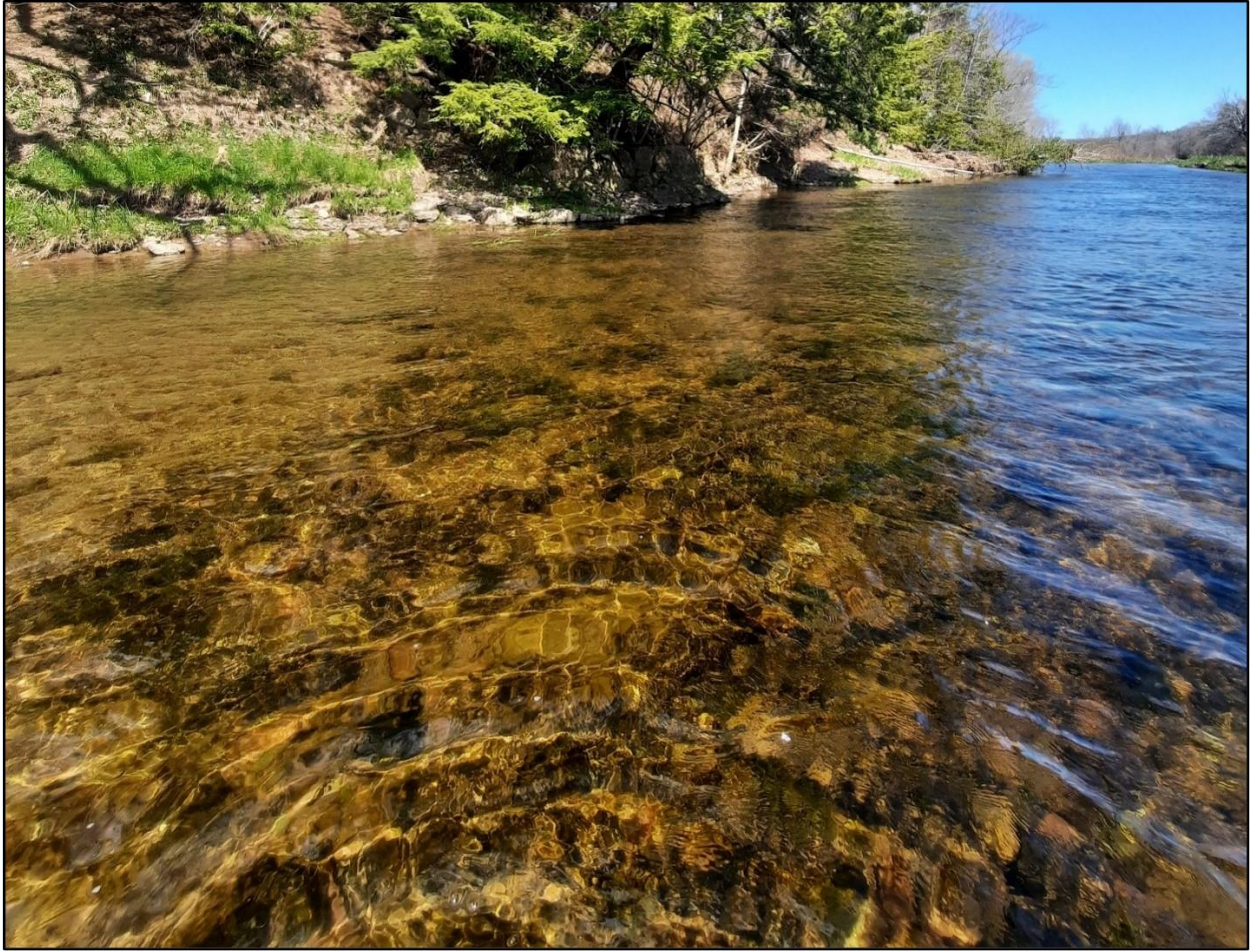
Figure 85: Bedrock exposed (black patches under surface)

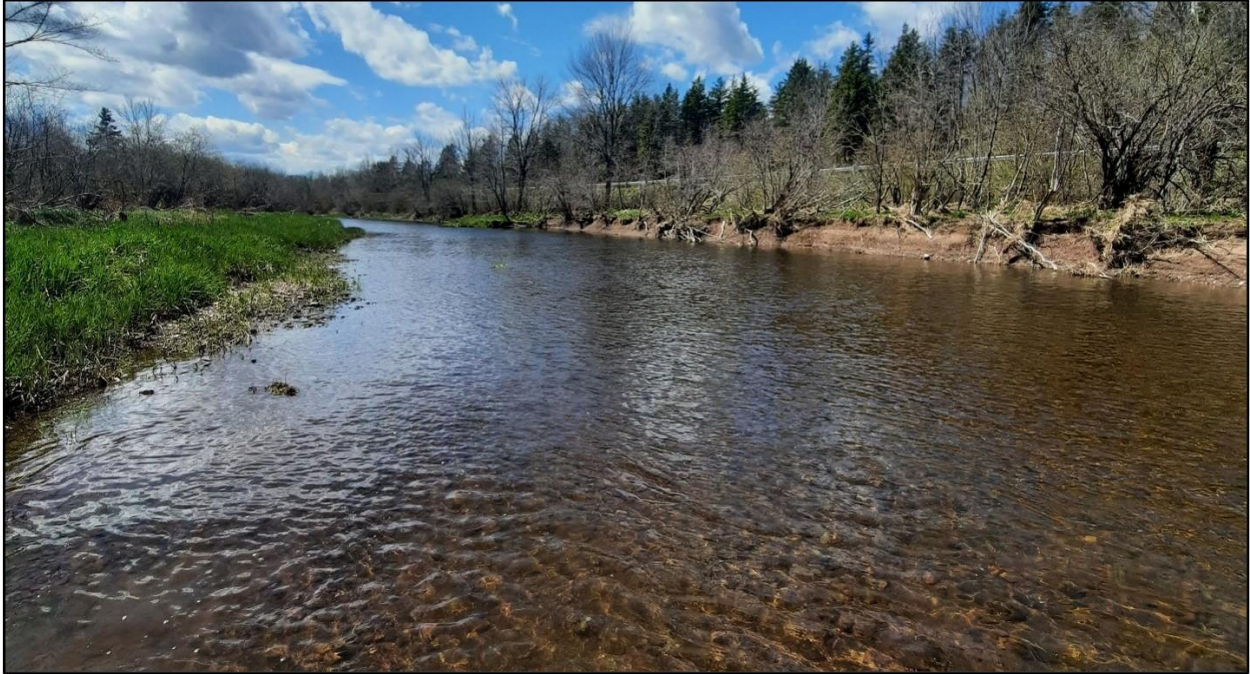
Figure 88: Erosion visible where Dunmore Road runs along the South River

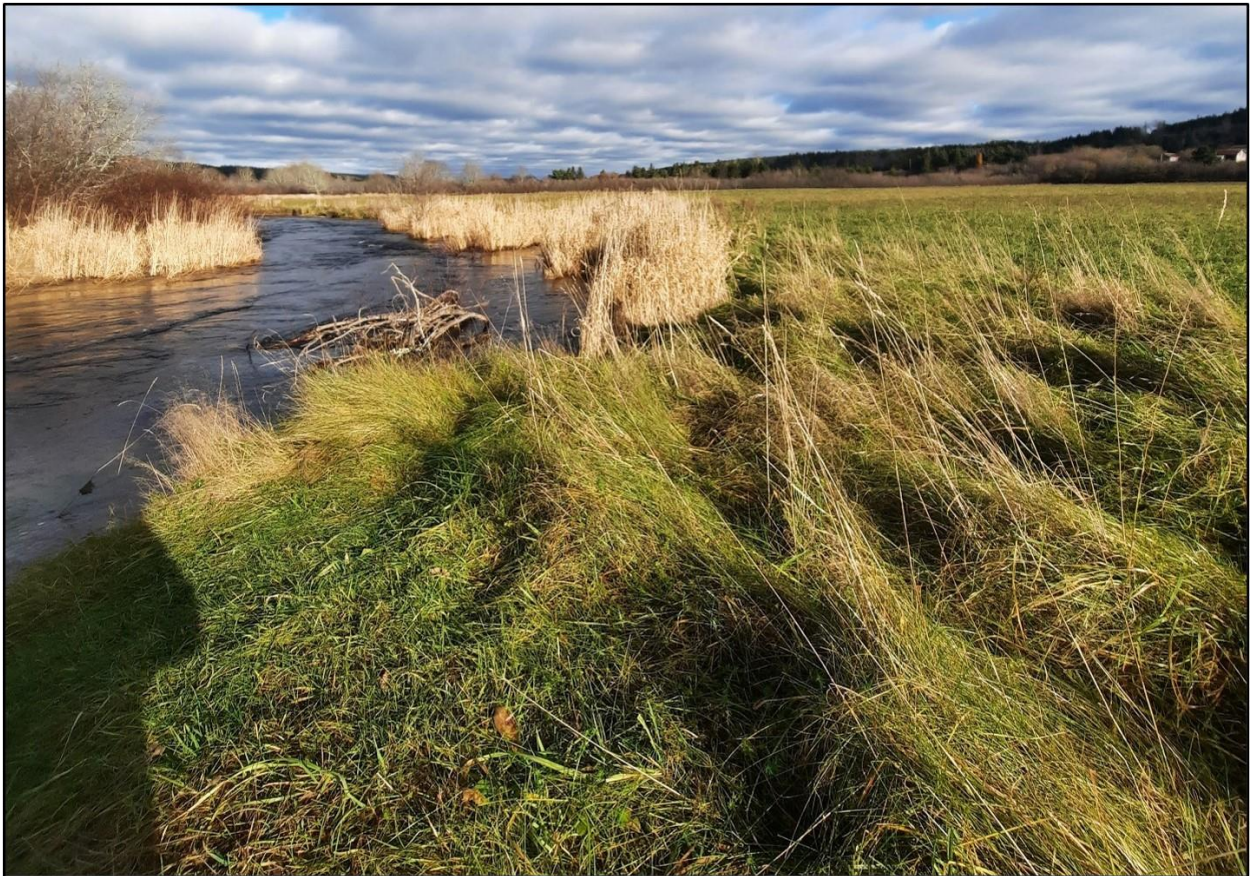
Figure 89: Agriculture field lacking sufficient riparian zone

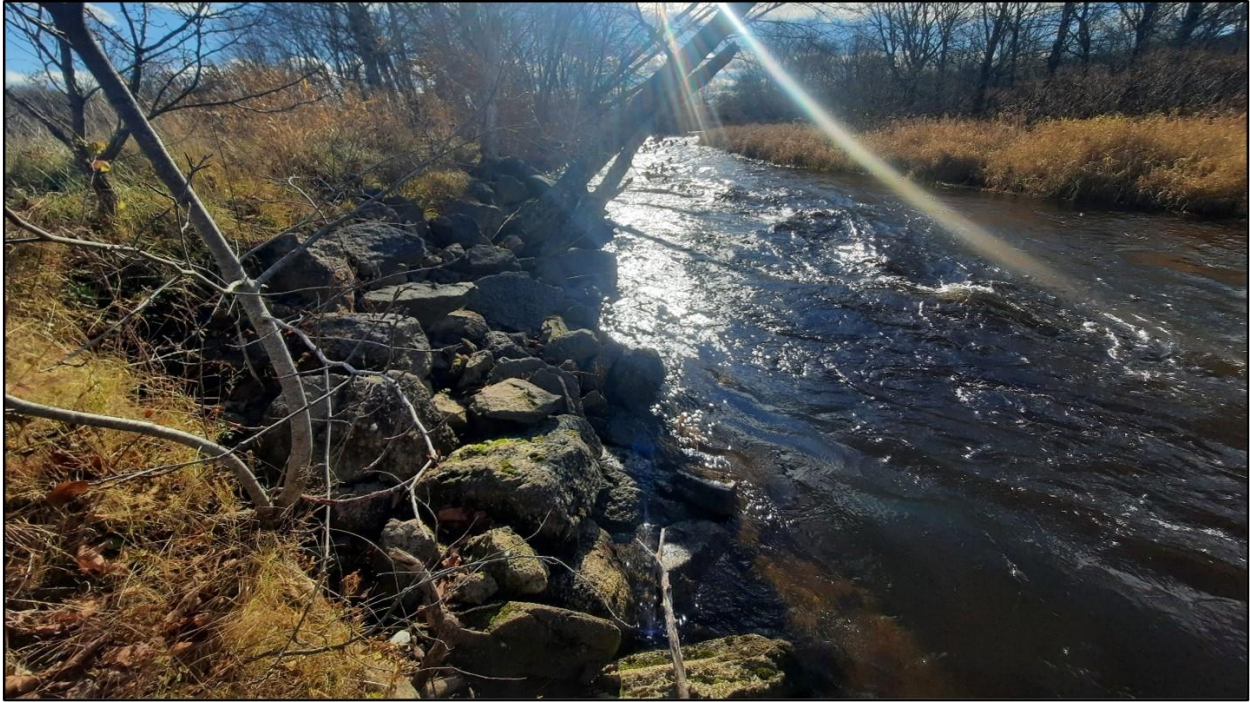
Figure 90: Old field stone installed by landowner along agriculture fields on the South River

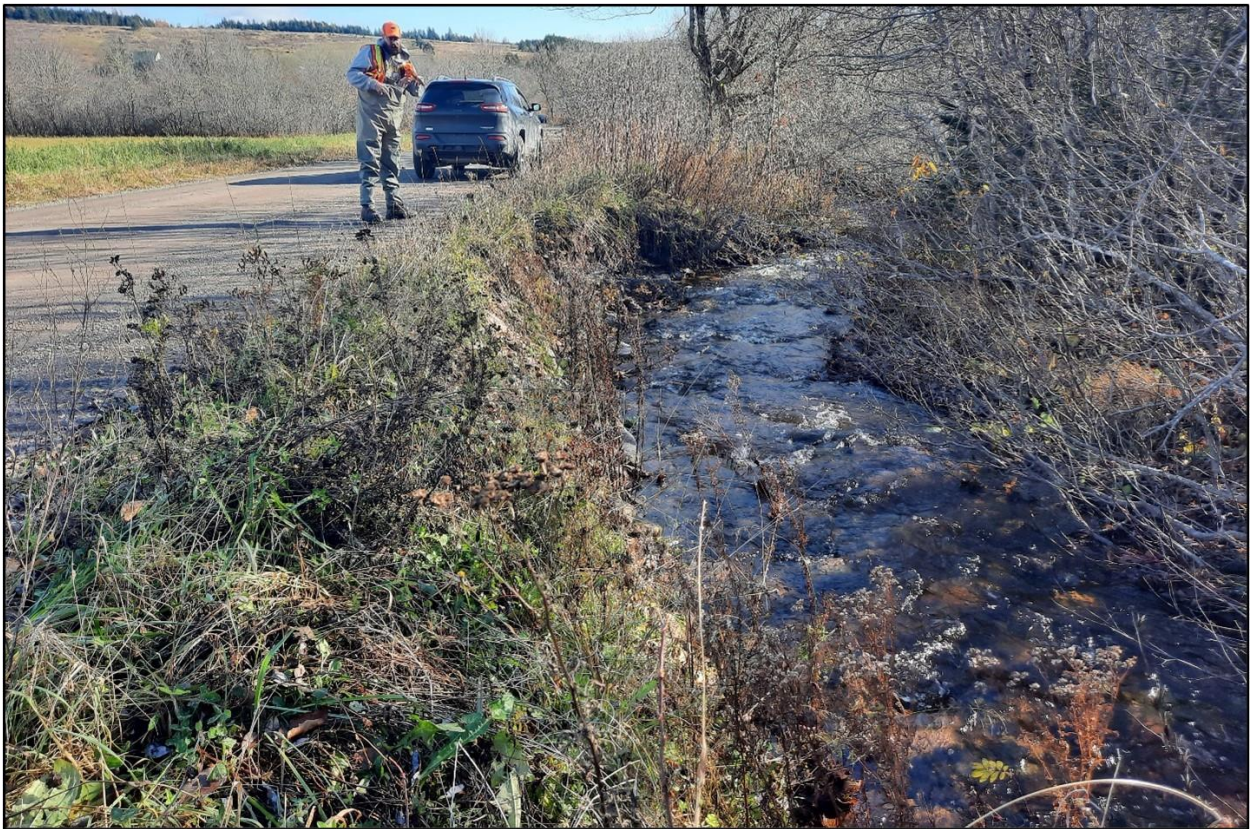
Figure 91: Tributary to the South River less than 1m from the road with no riparian zone

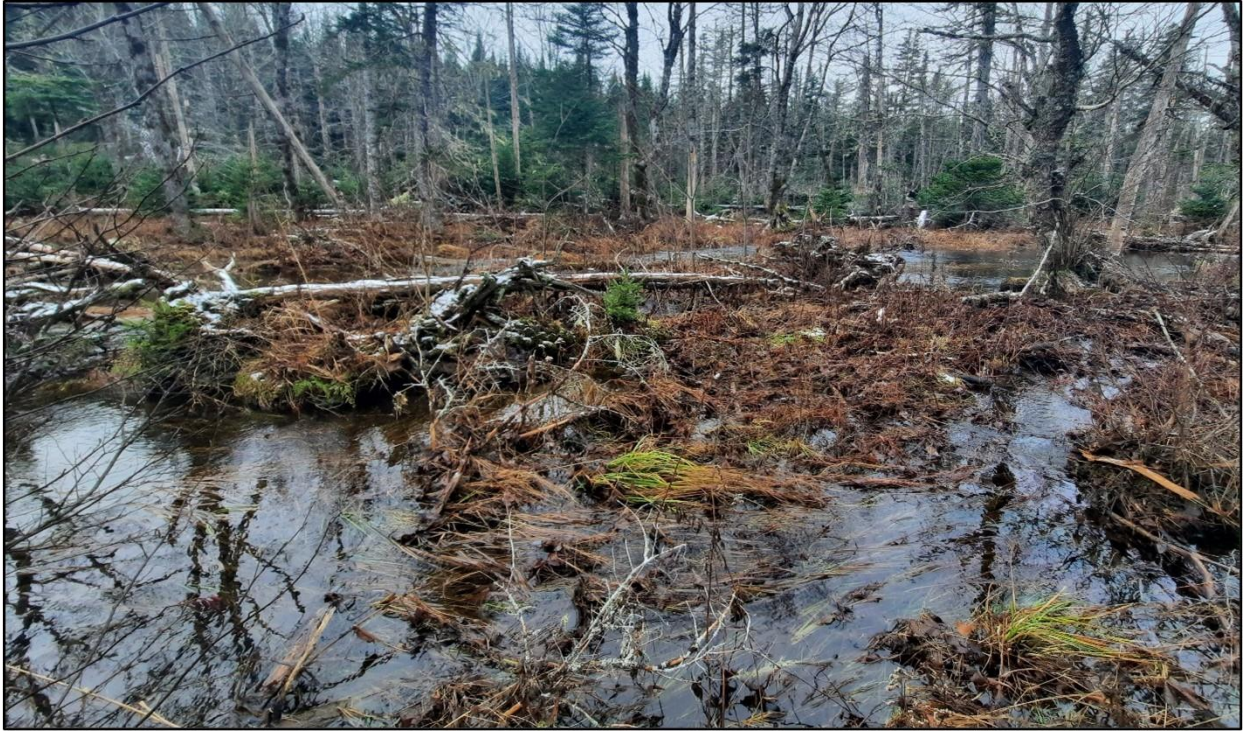
Figure 92: Upper South River off Argyle Road with no defined channel
