Atlantic Salmon Recovery & Conservation Plan for the South River Watershed

The Antigonish Rivers Association

May 31st, 2021

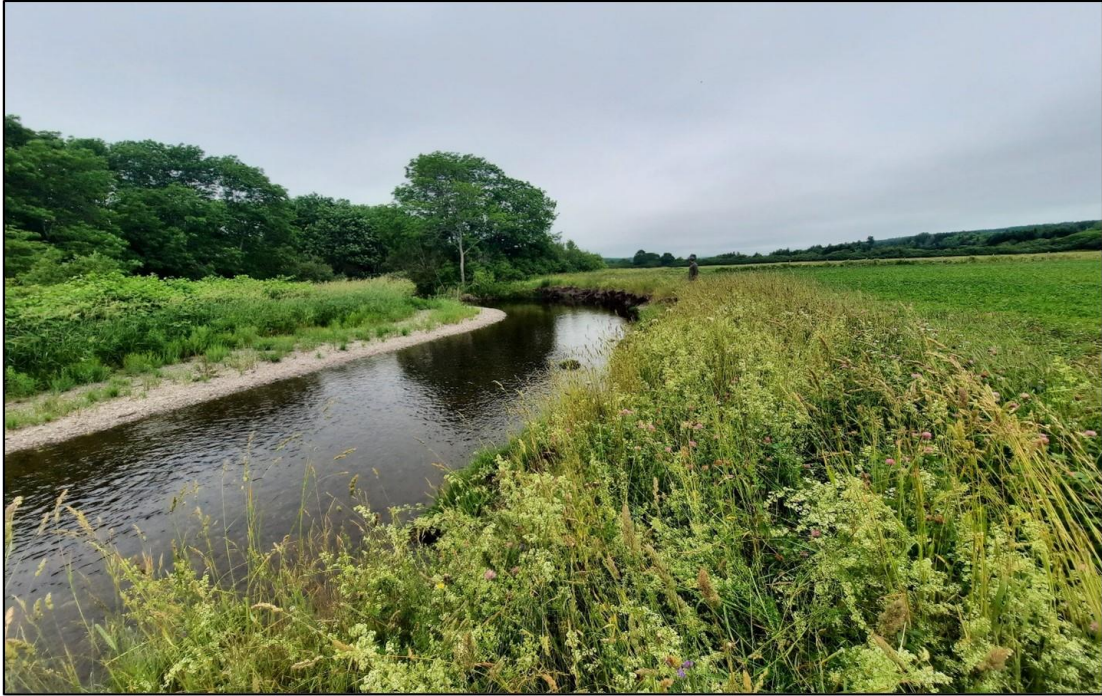
Figure 3: MacMillan's Farm site pre-restoration (2021)

Along the main branch of the South River, there are several sites where farmers have taken it upon themselves to fortify the river banks that run along their agricultural fields using large rock and cement slabs. This technique can help in the specific site where installed but can cause further damage directly downstream as the energy of the flow is being shifted, not dissipated. In 2019, the ARA successfully completed a major bank stabilization site. Due to the project's success, funding was secured for similar projects in 2020 and 2021.

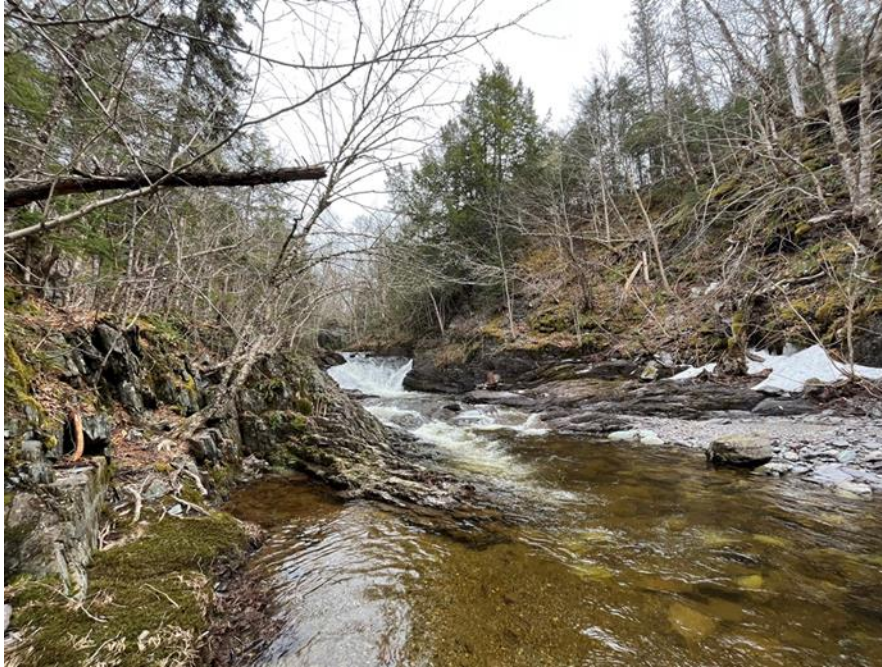
Figure 18: Polson's Brook falls

There is a major natural barrier waterfall approximately 1km upstream from its confluence with the South River. There is potential for some type of fish ladder to be installed at this site as the Polson's Brook is a cold-water tributary that has significant potential for upstream Atlantic Salmon spawning habitat, however, further assessments need to be completed in order to determine the feasibility of installing a fish ladder. The barrier waterfall limits full restoration potential for most of Polson's Brook at this time, but the restoration plan does include riparian zone tree planting in the lower reaches to stabilize the banks and provide a buffer zone between the agricultural fields and the river.

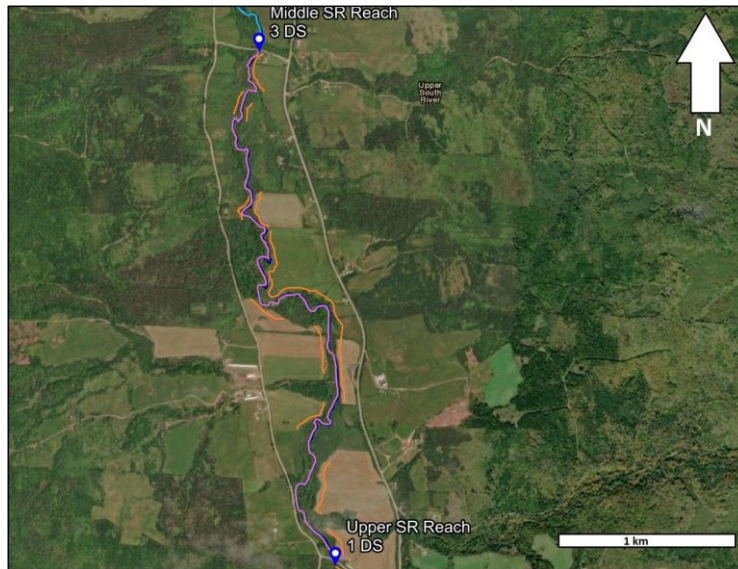
There are 3 reaches identified in the middle section of the South River main branch. Agricultural fields become the dominant land-use in Reach #1 where the river has been channelized to fit between the Dunmore Road to the west and the Highway 316 to the East, ensuring maximum area for pastoral and haylage fields. In Reach #2, the Fraser's Mills Fish Hatchery has been in operation for over 30 years and the primary water reservoir dam upstream from the hatchery has been present in some form or another on the South River since the early 1800's when it was originally used as a mill dam. There is minimal riparian buffer zones along the entire section, however there is notably significant less riparian zones along the South River in Reach #3 as seen in figure 19 below.

Figure 20: Aerial map of Reach #3. River highlighted in pink and bank lacking riparian zone highlighted in orange

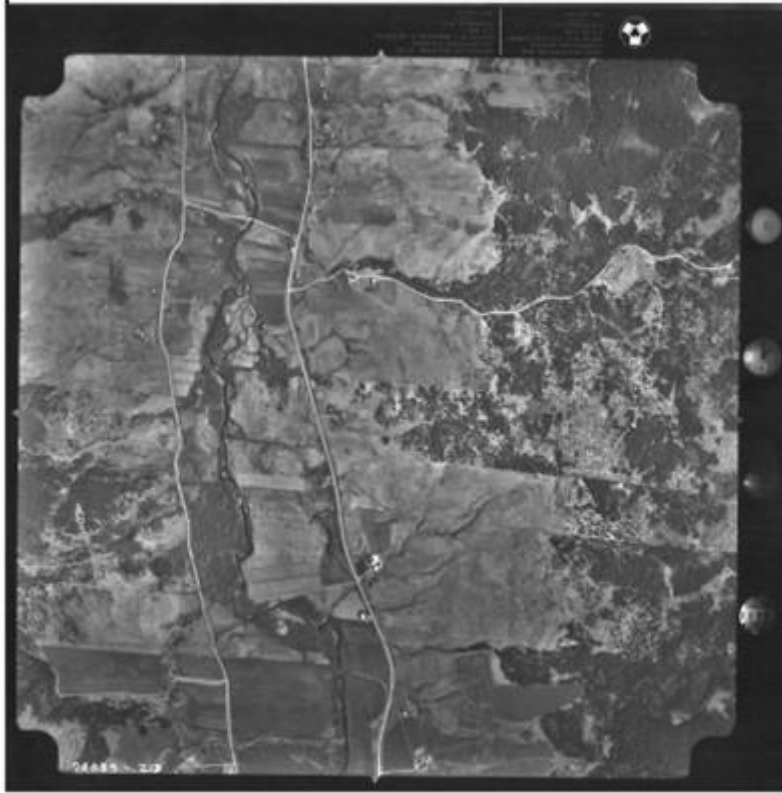
Figure 21: Middle South River (1974)

Table 10: Aerial Photo Series Observations		
Date Range	Figure #	Observations
1974 – 1979	21-22	1974 shows a well defined channel. By 1979 the channel has widened and on turns in the stream there are high levels of erosion leading to braiding of the stream. No signs of riparian zones are left on the farm fields.
1979 – 1990	22-23	The previously formed channels are becoming the main channels and the river is widening drastically. Riparian zone depletion continues which is speeding up the erosion.
1990 – 1997	23-24	The old channels have dried up and the previously formed channels are now the main channel. There are sharper meanders however overall, the channel is straightening out.
1997 – 2018	24-25	The channel remains intact, but erosion and even sharper meanders continue to occur. There are more wooded buffer zones on the river banks downstream from the farm fields.

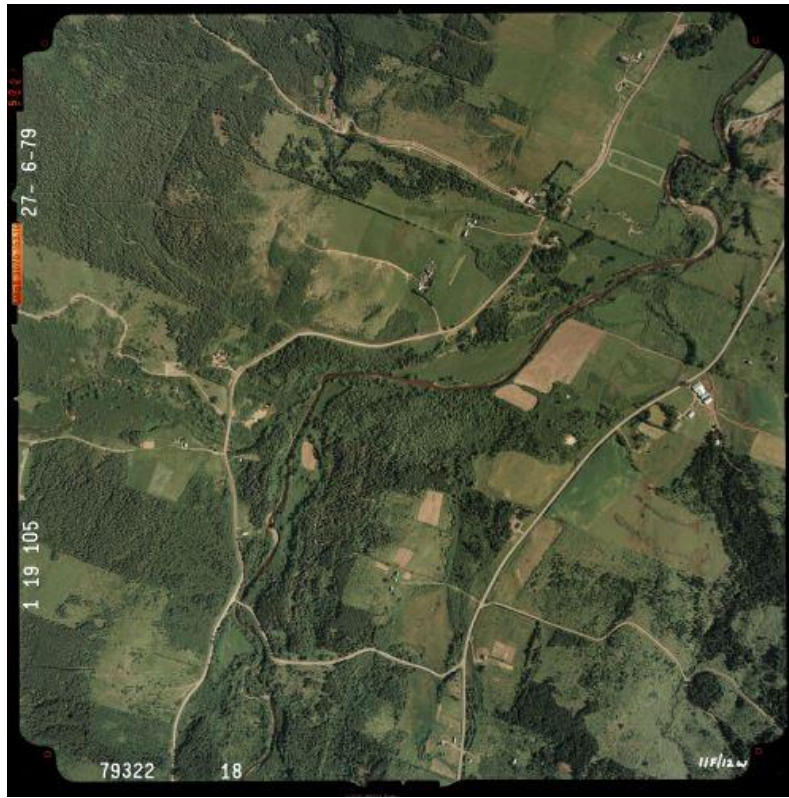
Figure 30: Pinevale Brook Confluence (1979)

Table 13: Aerial Photo Series Observations		
Date Range	Figure #	Observations
1979-1990	30-31	There is more riparian zone vegetation at the bottom of Pinevale Brook which has stabilized the stream. The channel is more well defined. Upstream from the mouth of Pinevale Brook on the main branch of the South River there has been a reduction in riparian zone vegetation and the land to the east has been deforested for agricultural purposes. The removal of riparian zone vegetation upstream could result in erosion and the deposition of sediment towards the mouth of Pinevale Brook.
1990-2007	31-32	There are no notable changes in adjacent land use. There is, however, noticeably more riparian zone vegetation which will further strengthen the channel's integrity.
2007-2018	32-33	Three houses have been developed to the south of the Pinevale Brook mouth and the channel is beginning to widen. Further upstream Pinevale there has been development on the first sharp meander after the road crossing. This development near the stream along with the removal of riparian zone vegetation presents more rapid erosion potential.

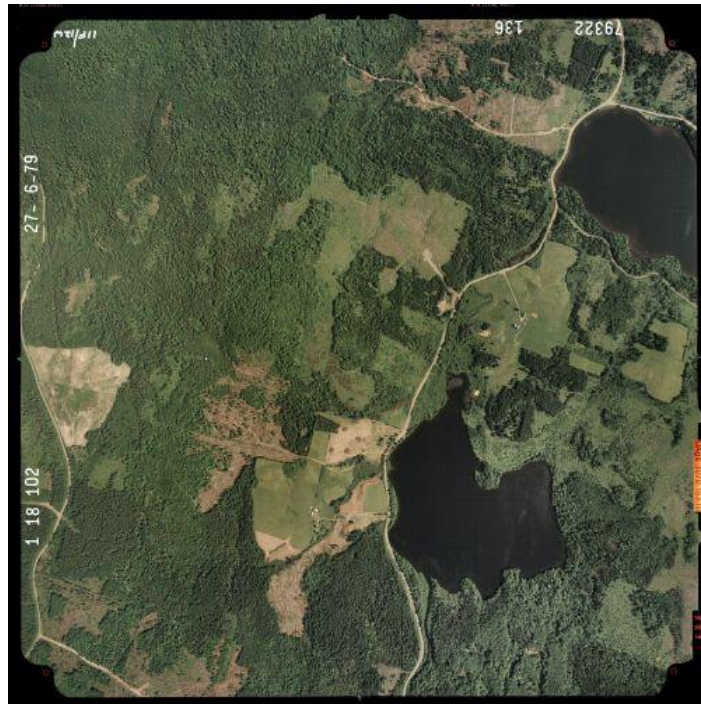
Figure 34: Upper Pinevale Brook (1979)

Table 14: Aerial Photo Series Observations		
Date Range	Figure #	Observations
1979-1990	34-35	Along the bank as Pinevale Brook enters Cameron’s Lake there is substantial deforestation. There was a riparian zone vegetation buffer left intact. At the southernmost end of the lake, early signs of erosion are apparent and as the stream exits Cameron’s Lake braiding has begun to occur.
1990-2007	35-36	The area that has previously been deforested has since been replanted. Erosion at the southern point of the lake continues and braiding of the stream is still visible.
2007-2018	36-37	Thicker tree cover is visible on the properties adjacent to Pinevale Brook and Cameron’s Lake. The braiding of the channel as the brook exits the lake has resulted in the widening of the channel.

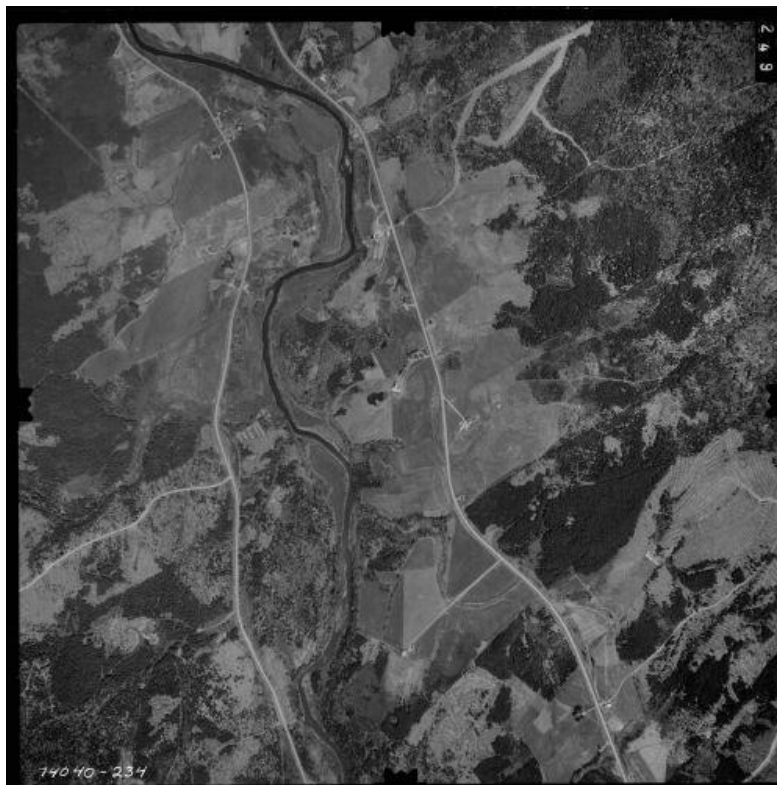
Figure 42: Lower South River (1974)

Table 16: Aerial Photo Series Observations		
Date Range	Figure #	Observations
1974 - 1979	42-43	There are no notable changes with property use adjacent to the river, however, upstream from the farm there is early signs of erosion and widening of the channel.
1979 - 1990	43-44	At the aerial photo site, land on both sides of the river has been deforested and turned into fields for farming purposes. A buffer of riparian zone vegetation was left, preventing rapid erosion potential. Land northwest of the farm site has also been clear cut. At this site, there was complete removal of riparian zone vegetation. This will speed up erosion processes and can be very detrimental as the site is on a sharp meander in the river.
1990 - 2018	44-45	The fields across the river from the farm site contain more vegetation, as one of the fields has returned to being entirely trees. Immediately downstream, a small quarry has been built. Approximately 1km upstream from the farm, the stream is beginning to braid. This could be due to housing development along the river.

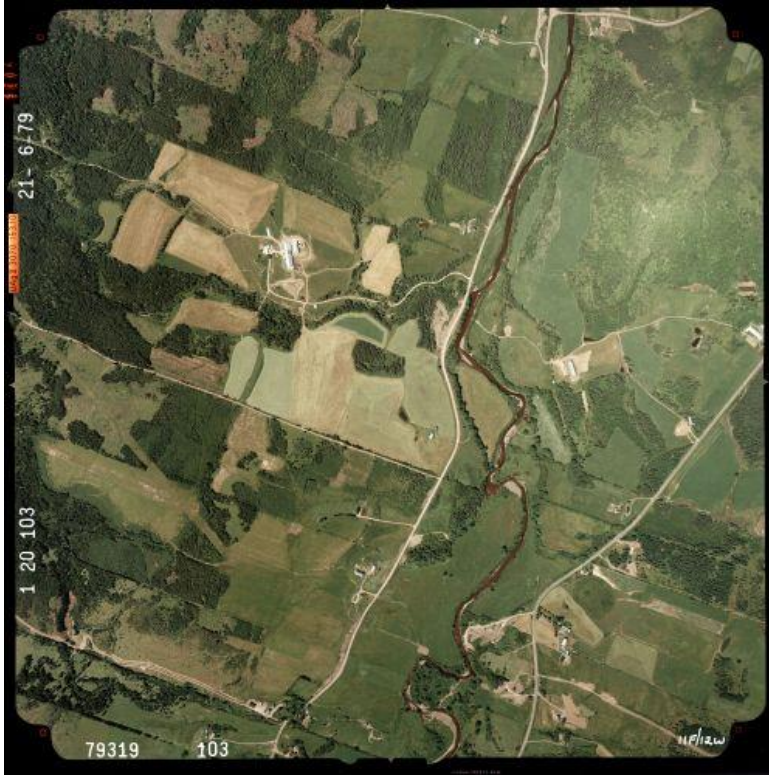
Figure 46: Farm Crossing (1979)

Table 17: Aerial Photo Series Observations		
Date Range	Figure #	Observations
1979-1990	46-47	There are no notable changes with adjacent land use, however, upstream there are more distinct gravel bars being formed and the stream is beginning to braid.
1990-2007	47-48	Downstream from the farm crossing, there is less riparian zone vegetation. There is visibly less meander in the stream and degradation of the previously formed gravel bars upstream.
2007-2018	48-49	The grassy land on the east side of the farm crossing site has been turned into a field for agriculture use. Upstream, the gravel bars are beginning to regenerate.

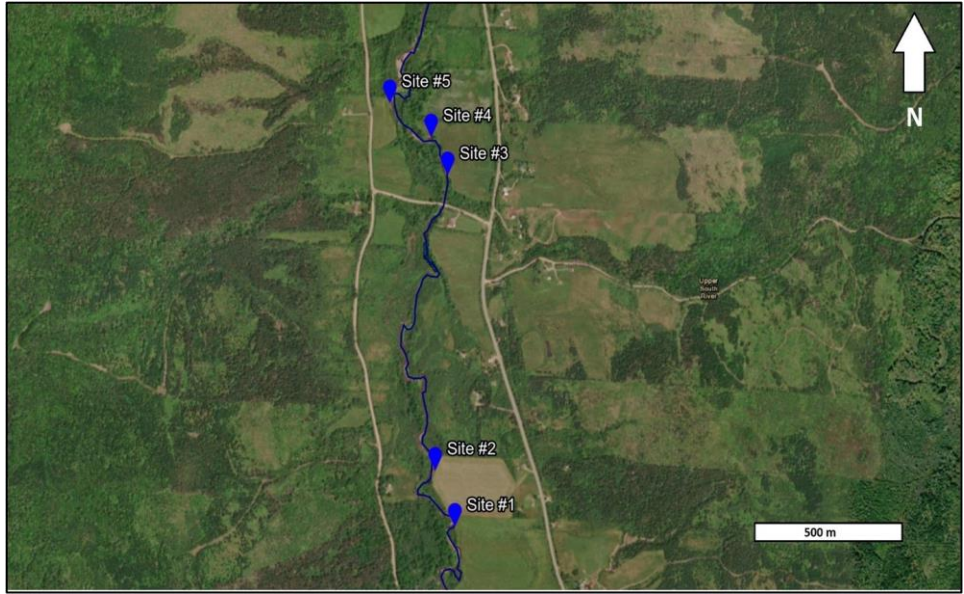
Figure 52: Aerial Map of South River main channel work sites 1-5

Site #	Coordinates	Length	Area Restored	Overview of Restoration Required
1	45.4615249N, -61.9391565W	80m	1,600m ²	Bank stabilization using armour stone rip rap and tree root wads, riparian zone enhancement
2	45.4630997N, -61.9400201W	70m	1,190m ²	Riparian zone restoration, bank rock using armour stone rip rap
3	45.4714533N, -61.9394696W	30m	570m ²	Bank stabilization using stone rip rap and root wads, installation of armour stone kickers, riparian zone enhancement
4	45.4725314N, -61.9402011W	30m	180m ²	Riparian zone restoration
5	45.4735043N, -61.9420337W	40m	240m ²	Riparian zone restoration
6	45.5082775N, -61.9359251W	275m	46,750m ²	Major riparian zone enhancement – tree planting entire field
7	45.5338261N, -61.9176563W	60m	300m ²	Riparian zone enhancement
8	45.5488285N, -61.9074298W	75m	450m ²	Riparian zone restoration
9	45.5500202N, -61.9078287W	30m	180m ²	Riparian zone restoration

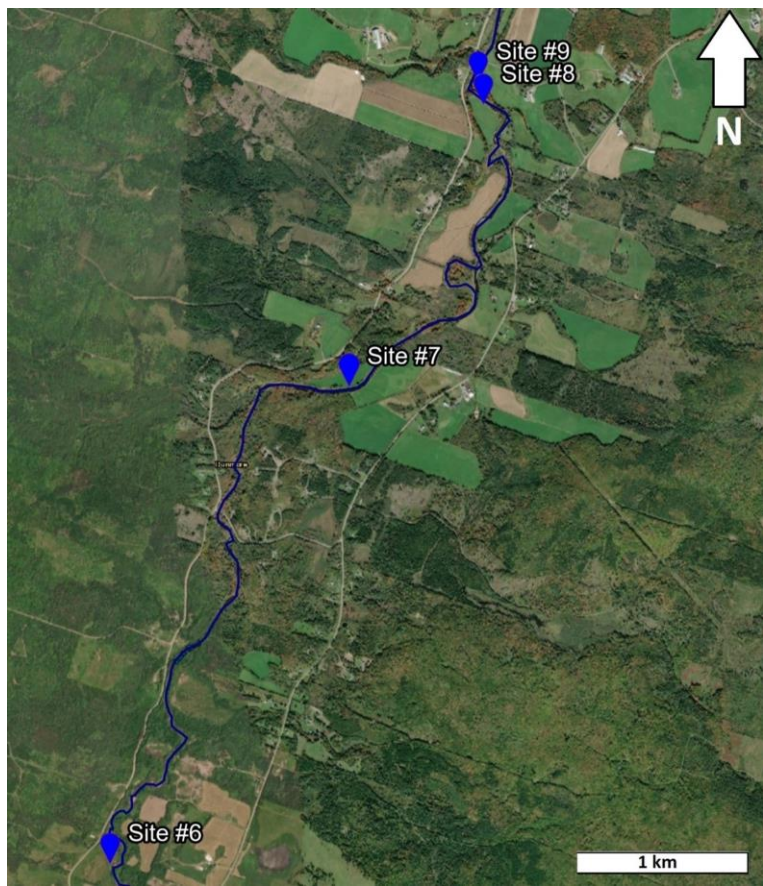
Figure 53: Aerial map of South River main channel work sites 6-9

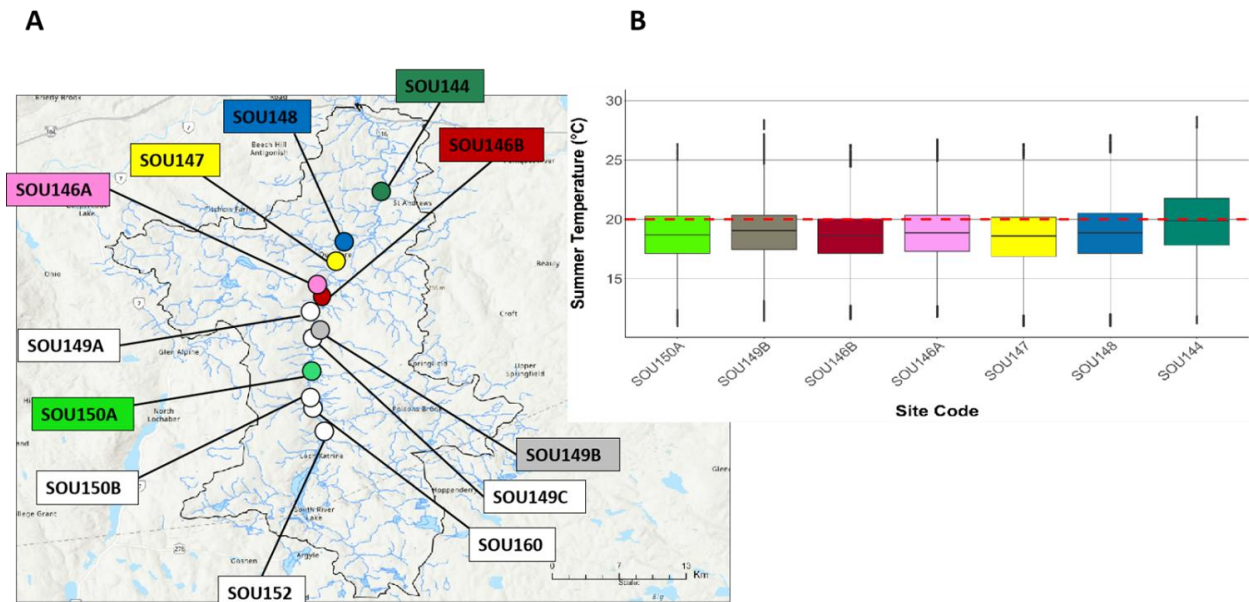
Within the South River there was little variation in average summer temperature across sites, with nearly all sites recording an average summer temperature below 20 °C (Figure 66B). SOU144 (teal green boxplot), was the only site that recorded an average summer temperature of 20 °C (Figure 66B).

All sites recorded temperatures greater than 25 °C, at some time within the summer, but it was less common in upstream sites as indicated by the darker lines on the boxplots (Figure 66B). The highest maximum temperature reached was 28.61 °C, which was recorded at SOU144 in August. SOU144 Spent approximately 70% of August greater than 20 °C, and a quarter of August greater than 23 °C.

Overall, the vertical profile of the mainstem within the South River showed little to no variation within average temperatures, but high variation in temperatures at sites where temperatures went from 11-28 °C throughout the summer (Table 25; Figure 66B).

Figure 66: A: South River temperature probe locations. B: Corresponding boxplot graphs.

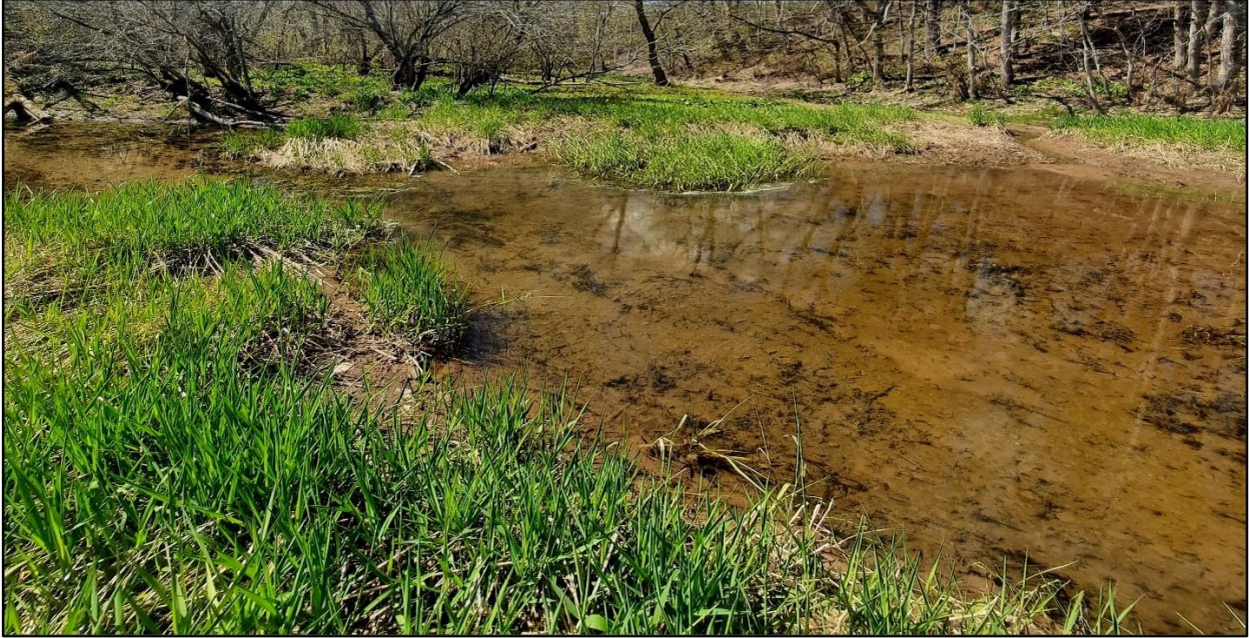
Figure 84: Backwater areas are important habitat for juvenile salmon

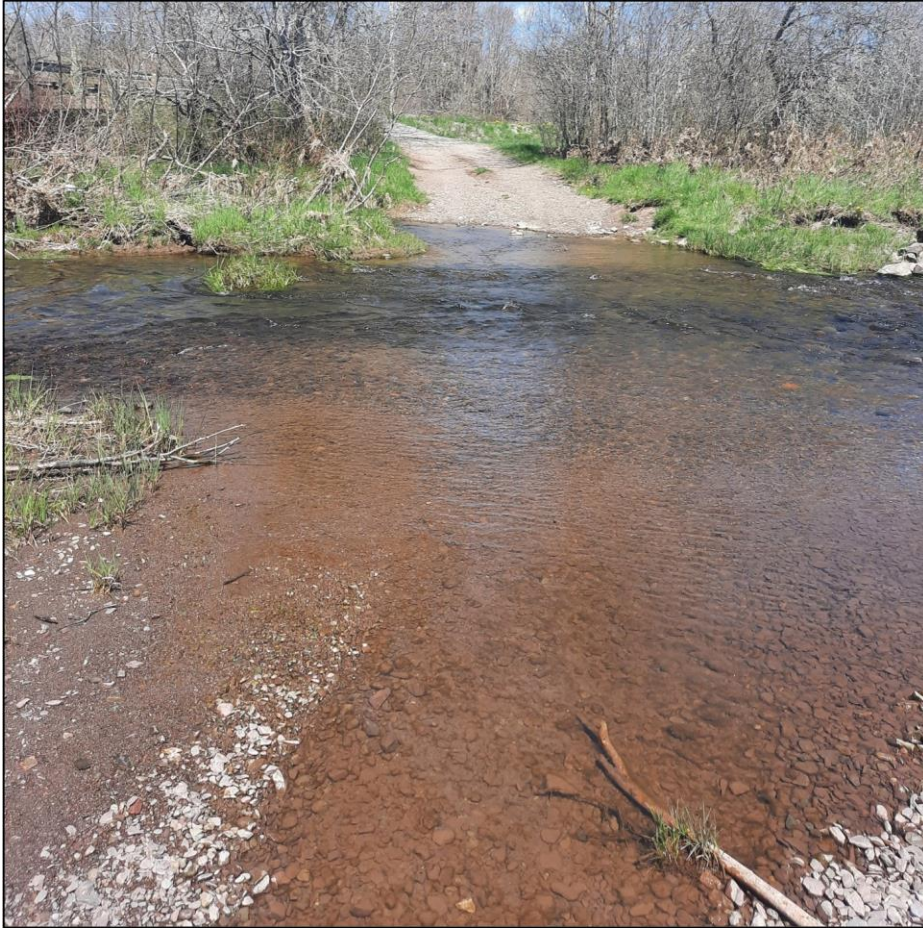
Figure 86: Tractor ford crossing the South River
